Aviation Investigation Final Report

Location:	Telluride, Colorado	Accident Number:	CEN21FA007
Date & Time:	October 5, 2020, 13:04 Local	Registration:	N4444K
Aircraft:	Beech S35	Aircraft Damage:	Substantial
Defining Event:	Loss of control in flight	Injuries:	2 Fatal
Flight Conducted Under:	Part 91: General aviation - Personal

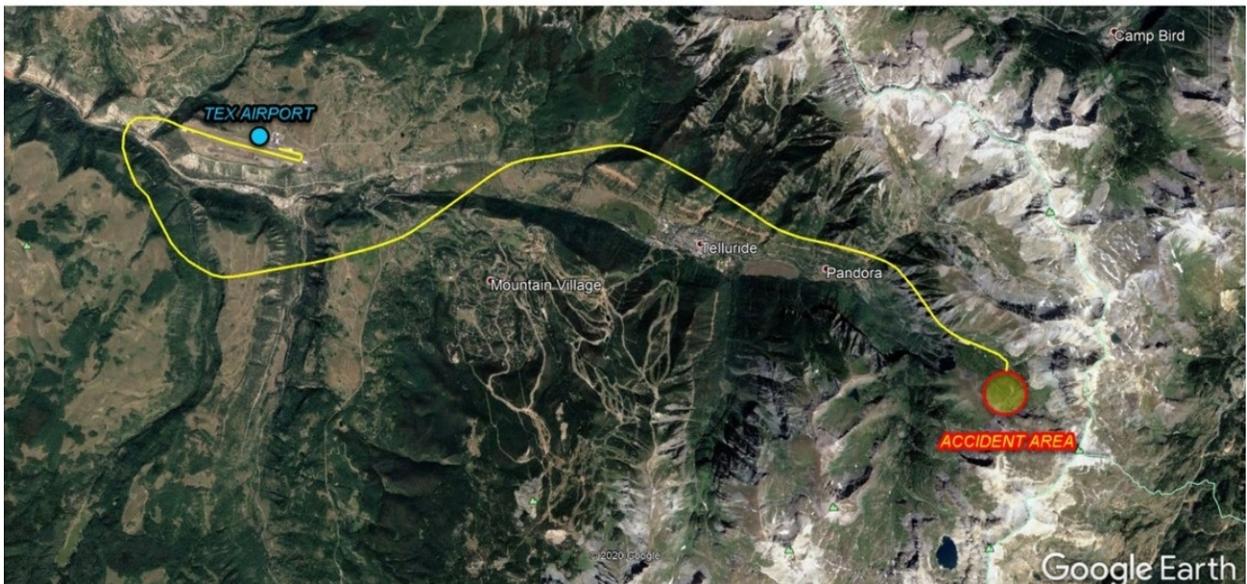
Figure 1. ADS-B flight track from TEX to the accident location.

The airplane departed on a planned visual flight rules cross-country flight from runway 27 at TEX. Automated dependent surveillance-broadcast (ADS-B) data showed that the airplane had a normal takeoff and made a subsequent left turn toward the east. The airplane proceeded east into a box canyon and an area of rising terrain. The data showed that, before entering the box canyon, the airplane did not maneuver toward the west, where the terrain was lower than the surrounding terrain. The data also showed that the airplane was in a gradual climb for about 8 miles into the canyon and that the airplane then made a right turn to the south, which was immediately followed by the airplane’s impact with terrain. See figures 1 and 2. No known radio distress calls were received from the pilot after takeoff.
